Delayed Rupture of Flexor Pollicis Longus after Volar Plating for a Distal Radius Fracture

Chul-Hyun Cho, MD, Kyung-Jae Lee, MD, Kwang-Soon Song, MD, Ki-Cheor Bae, MD

Department of Orthopaedic Surgery, Dongsan Medical Center, Keimyung University School of Medicine, Daegu, Korea

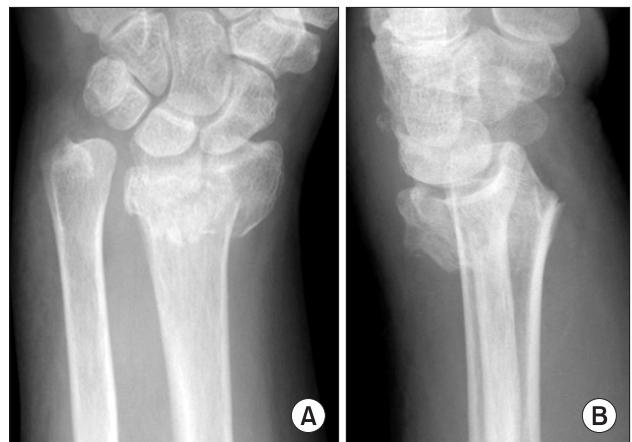
Fig. 1. Initial anteroposterior (A) and lateral (B) plain radiographs show the intra-articular comminuted distal radius fracture with dorsal displacement.

A 63-year-old right-handed woman sustained a right intra-articular comminuted distal radius fracture with dorsal displacement (Fig. 1), a right femoral shaft fracture, and a hemothorax in a motor vehicle accident. Open reduction and internal fixation was performed using 3.5-mm T-LCP for the distal radius fracture at 12 days after the trauma,

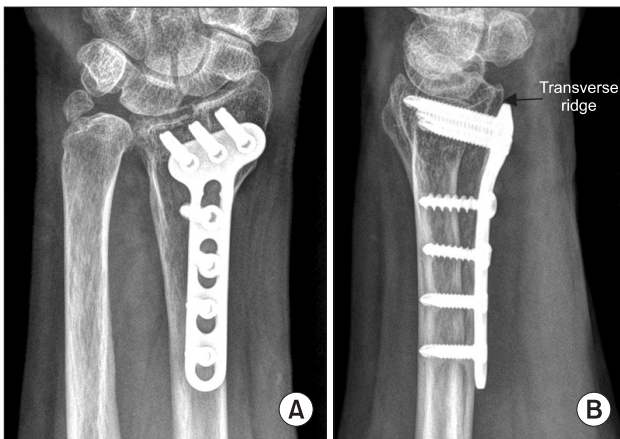
Fig. 2. Anteroposterior (A) and lateral (B) plain radiographs obtained at 40 months after surgery show no interval change in comparison with radiographs obtained immediately after surgery.

and the plate was covered by the pronator quadratus after fixation. Immediate postoperative plain radiographs revealed acceptable restoration of radial inclination, radial length, and volar tilting, except an approximate 2 mm step-off of the articular surface. The plate was placed tightly to the distal radius without any gap, and even though the distal edge of the plate was very close to the transverse ridge of the distal radius, it did not reach the distal portion of the transverse ridge. Plain radiographs at 8 months after surgery revealed bony union without further collapse of the distal fragment compared to that of the immediate postoperative radiographs, and range of motion of the right wrist was normal. Accordingly, we recommended plate removal, but the patient refused, stating that she was experiencing no specific discomfort.

In our case, there was no long-term use of steroids and the Synthes 3.5-mm T-LCP used was widely available and not custom-made. Additionally, no history of injury before surgery or of thumb abnormality after surgery were noted. Follow-up plain radiographs revealed bony union without further collapse of the distal fragment, as compared with radiographs obtained immediately after surgery. However, even though the plate was not violating the distal part of the transverse ridge, it was at the transverse ridge level. We found that the plate shaft was covered by the pronator quadratus, but that the distal edge was exposed. Additionally, the FPL tendon ruptured right at the point where it met the exposed distal edge. We suggest that the rupture was due to friction from the exposed distal edge of the plate at the transverse ridge, because the pronator quadratus does not attach to the distal part of the

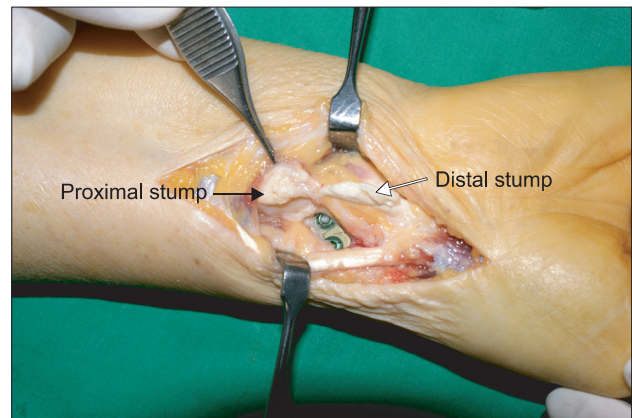
Fig. 3. Intraoperative findings show a total rupture of the flexor pollicis longus tendon with granulation and fraying of tissue in the ruptured margin.

She visited our hospital at 40 months after surgery and reported that she had a sudden thumb flexion limitation during washing 10 days ago. She had no associated pain and no warning symptoms such as tendon irritation. A physical examination revealed that she could not actively flex the right interphalangeal joint of her thumb, although the range of motion of her other joints and sensory findings were normal. Radiographic findings revealed no definite interval change (Fig. 2). Ultrasonographic findings showed that the FPL tendon had ruptured, and the proximal stump was found at the radiocarpal joint. We performed a surgical exploration and found that the distal edge of the plate was exposed even though the pronator quadratus was nearly completely covering the plate. The FPL tendon had ruptured over the distal edge and was frayed (Fig. 3). We performed complete debridement of the granulated and frayed tissue in the ruptured margin, removed the plate, and performed a primary repair of

the tendon using the modified Kessler method. The patient wore a thumb spica cast for 3 weeks and then began passive-motion exercises. The patient had no movement restriction of the right thumb at 6 months after surgery.

As reported by some authors, when the FPL ruptures because of friction against the plate over a long period of time, primary repair is impossible in most cases because of a hypertrophied tenosynovium and a tendon defect with fibrous tissue and retraction; thus, a tendon graft or tendon transfer is necessary. However, although the rupture in our patient occurred 40 months after the initial surgery, findings from the exploratory surgery revealed little retraction; thus, a primary end-to-end repair was possible even after removing some fibrous tissues and a frayed tendon. It is unclear why such unusual circumstances occurred.
